IAAI JOURNAL

Vol. 22, No. 4, December 2011

FIRE ON THE FREEWAY

IS THIS TRUCK GEAR A COMPETENT IGNITION SOURCE OR JUST A LUMP OF METAL?

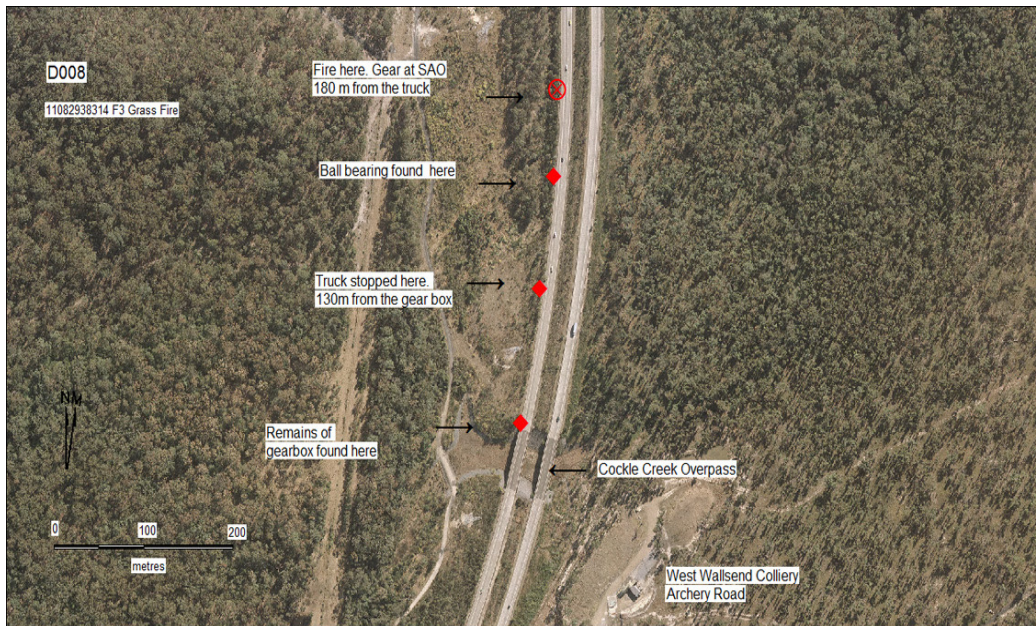
The location of the gear and fire is marked in the top centre. A truck was seen to be parked approximately 190m to the south of the fire a Highway Patrol vehicle was in attendance. A rectangular oil stain was found at this site. The remains of a gear box were found approximately 120m to the South.

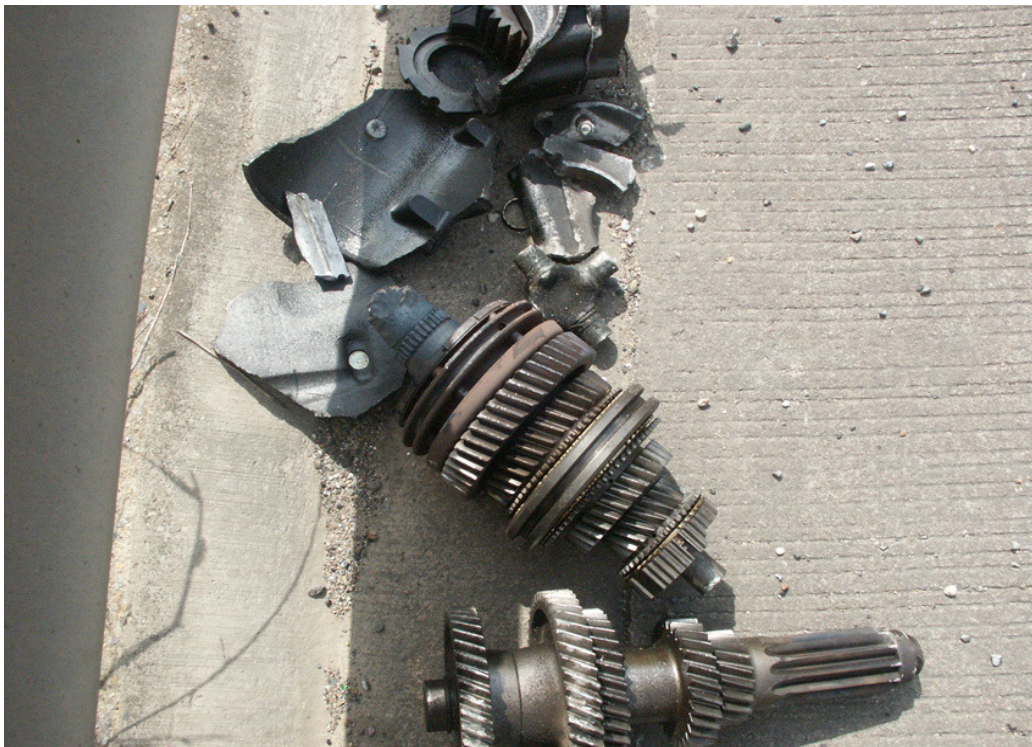
Approximately 110m to the South and on the Cockle Creek Overpass, were the remains of a truck gear box. The drive shaft was a light grey colour; it had been bent and fractured. The helical gears that were still on the shaft had the same bright orange colour seen on the gear from the SAO.

Having matched the size and colouring of the gears at both sites, it was concluded that the gear from the SAO was likely to have been heated while part of the gearbox found beside the road.

This collection of parts from a truck gear box was found on the Cockle creek overpass. The gears seen in the centre of the photograph have a fractured straight cut. The drive shaft in the top has also twisted and fractured. Its grey colour change suggests super heating. There are few traces of gear oil on the parts.

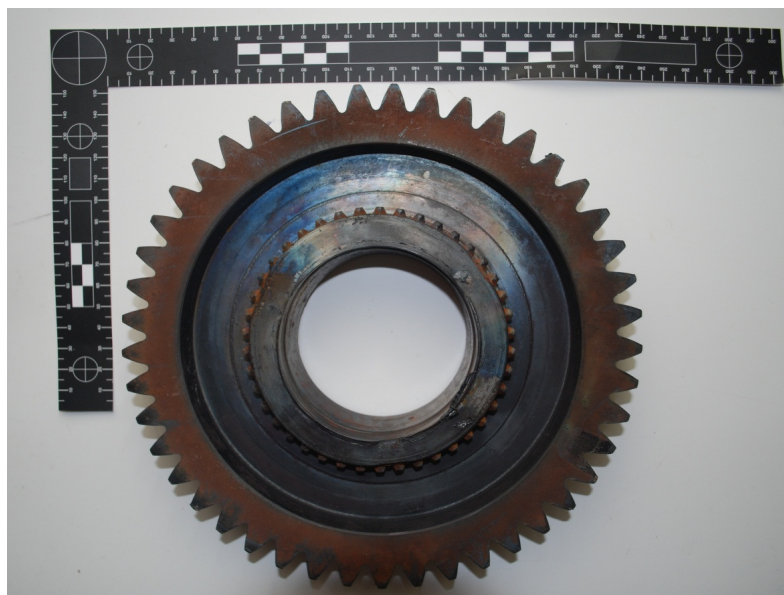
Figure 1. Gear recovered from the specific area of origin of a roadside fireground

This was straight cut and appeared to be either the first or reverse gear from a truck gear box. An examination of it showed that the ring of teeth normally engaged by the synchromesh and surrounding the hole for the shaft, had a bright orange colour. The gear had no coating of oil. The area surrounding the shaft had fracture lines consistent with metal from an adjacent gear being fused to it then having been separated by force. Concentric zones of colour were seen on the other side. A bright orange band near the shaft gave way to an orange /yellow colour.

These colour changes in the surface of the gear suggested that it had been exposed to extreme heat. The outer teeth of the gear showed damage consistent with being rolled/bounced on the concrete roadway.

Examination of the gear recovered from the fireground revealed it to be about 21 cm in diameter and 3.5 cm in thickness. It has an 8 cm diameter opening for a shaft and pyramidal teeth surrounding the shaft aperture for synchronisation. It weighs 4.75 kg. Examination of the face adjacent to the shaft aperture revealed the metal to be deformed (see figure 1). A number of mechanics were consulted and it was felt that the gear had been damaged by heat and that the degree of damage reflected heating to red-heat, approximating 450°C.
