FIREPOINT

Issue 4

August 2017

AAFI Journal

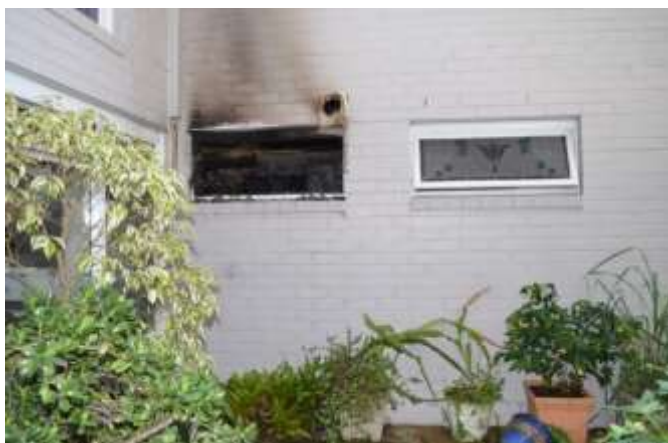
- There was minimal fire damage visible from the outside. The only area was a small window on the southern side of the building. This window was a kitchen window but located in the courtyard of an adjoining unit. The fire vented¹ out this window (refer Figure 5).

Figure 5 showing the southern wall of unit 25. The window on the left is the kitchen window.

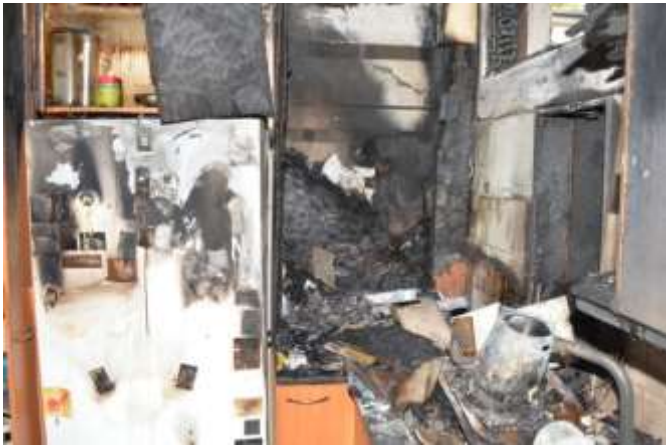
- In the downstairs lounge room there was heavy soot² damage throughout. This was similar upstairs in the bedrooms.
- The main area of fire damage was in the kitchen, in particular the SE corner of the kitchen (refer Figure 7). Here the concrete ceiling showed areas of clean burn³ in the corner above the small window that had failed.

Figure 7 showing the SE Corner of the kitchen. Note the clean burn to the top right side of the fridge.

- The 'V' pattern of clean burn on the fridge indicated the fire came from the bench top in the SE corner.
- The charring to the remaining overhead cupboards on the southern wall indicated the fire came from the bench top in the SE corner.

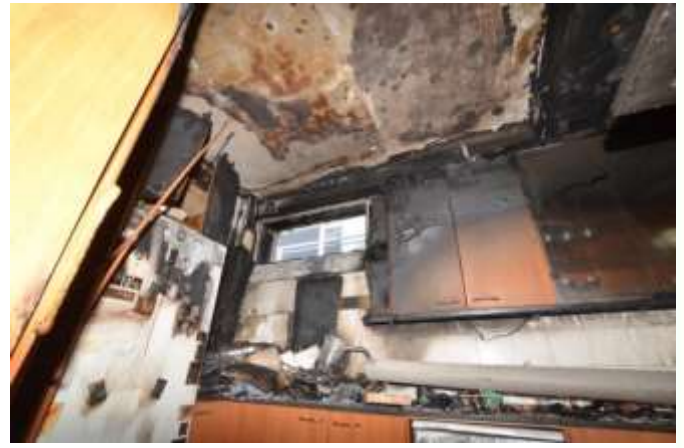
Figure 8 showing the ceiling above the SE corner of the kitchen.

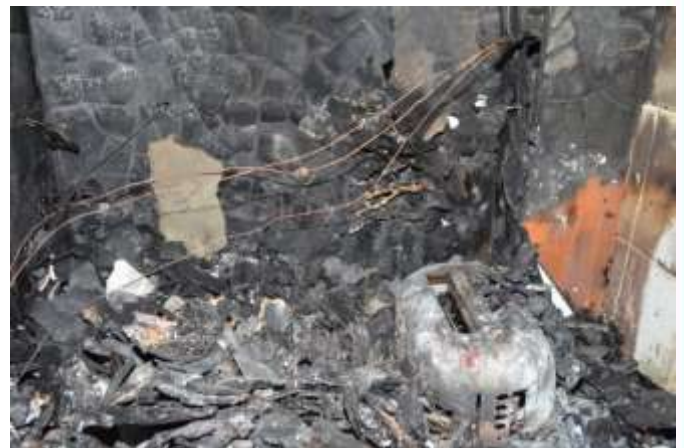
- All of the cupboards in this corner had been destroyed by the fire (refer Figure 9). This debris had fallen onto the bench top. Charring to the remaining timber cupboards pointed back to SE corner of kitchen. The fridge also showed an area of clean burn to its right side, pointing back to the SE corner.
- The microwave had fallen onto kitchen floor.
- AOO⁴ was the SE corner of the kitchen.

Figure 9 showing the remains of the enclosed appliance cupboard.

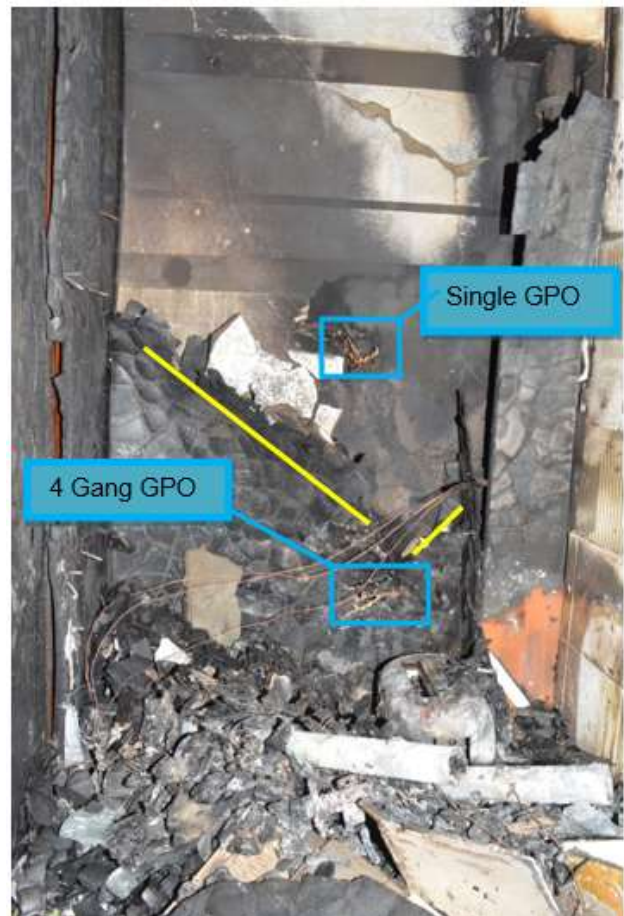
Figure 10 (photo 59) showing the AOO prior to excavation. Note the 'V' pattern on the back wall (yellow).

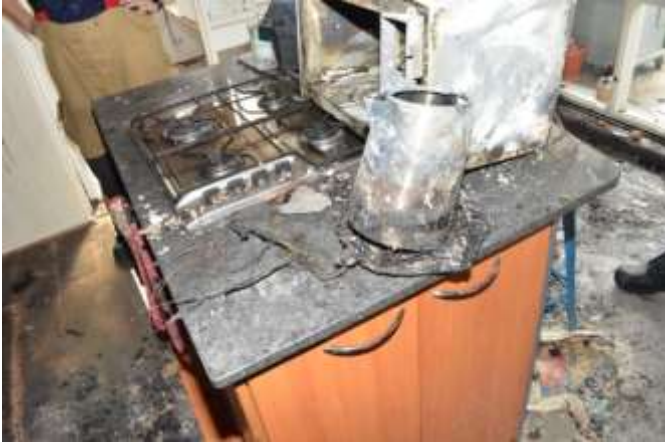
- The kettle showed fire damage from above, with the underneath plastics still intact. This device was ruled out as the source of ignition⁵ (refer Figure 11 and Figure 12).
- The toaster was located on the right side of the enclosed appliance cupboard. When removed the toaster had plastic fused to its right side. The left side showed a horizontal oxidation⁶ burn pattern (refer Figure 13). This indicated that the heat came from above and from the left side of this device. The base of this device had underneath plastics not melted (refer Figure 14). This device was ruled out as the source of ignition.
- The sandwich press was located on the left side of the enclosed appliance cupboard (refer Figure 15). Its right arm was melted with minimal damage underneath (refer Figure 16). This device was ruled out as the source of ignition.

Figure 11 showing the kettle. Note damage is consistent from above.

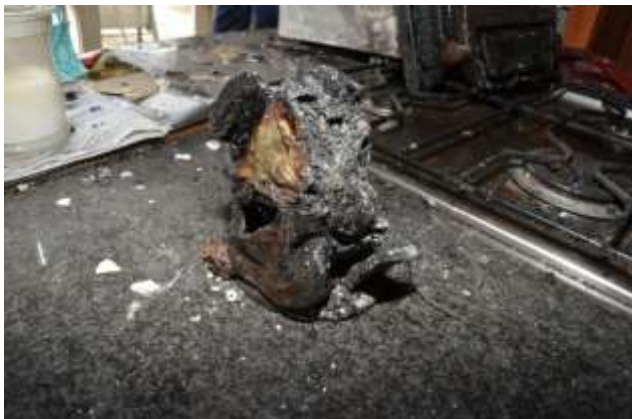
- The Ninja blender was located on the left side of the enclosed appliance cupboard (refer Figure 17). This device showed greater damage on its right side, with protection on its left side (refer Figure 18). There was no heat damage underneath. This device was ruled out as the source of ignition.
- The microwave showed severe fire damage with oxidation on most sides (refer Figure 19 and Figure 20). No plastic remained on the device. This appliance was located on shelf above the enclosed appliance cupboard and the 4 gang GPO⁷. This appliance is a possible ignition source.

Figure 17 showing the ninja blender. Note there is greater damage to one side (right).

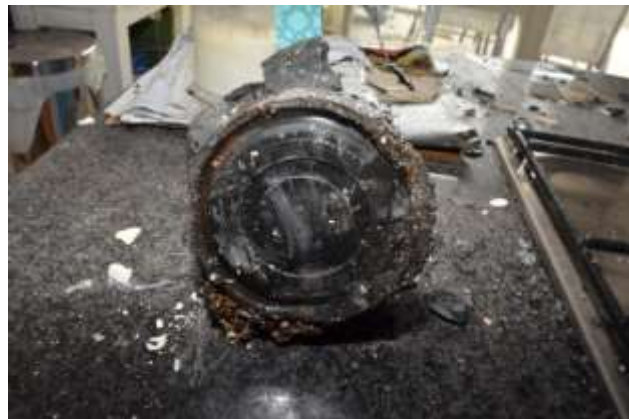
Figure 18 showing the underneath of the ninja blender press. Note the plastic still intact here.

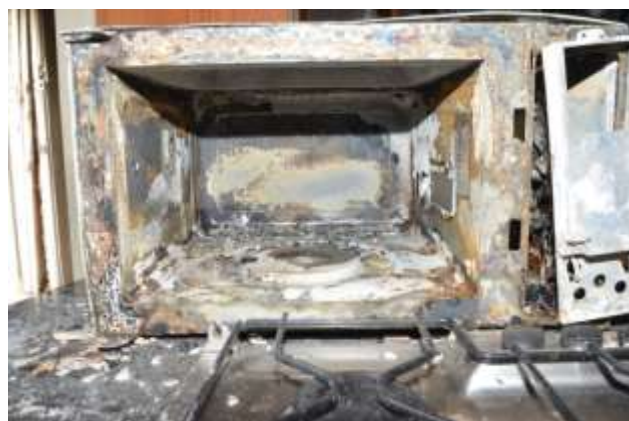
Figure 20 showing the inside of the microwave. Note the areas of oxidation are consistent all over the appliance.

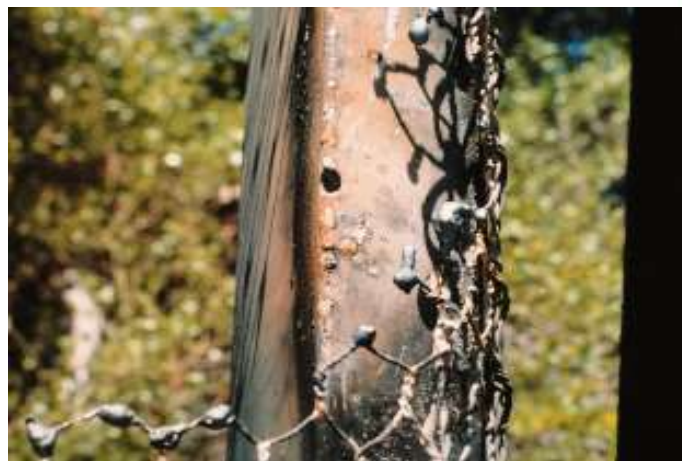
Photo 2

A 12 kilovolt electrical power line had dropped down and made contact with the metal screen around the racquetball court, photograph 2.

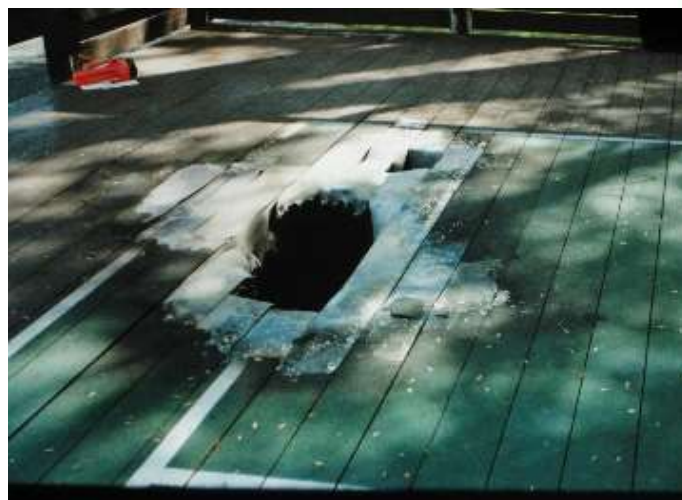
Photo 3

The power line continued down and burned a hole in the metal floor of the racquetball court, photograph 3.

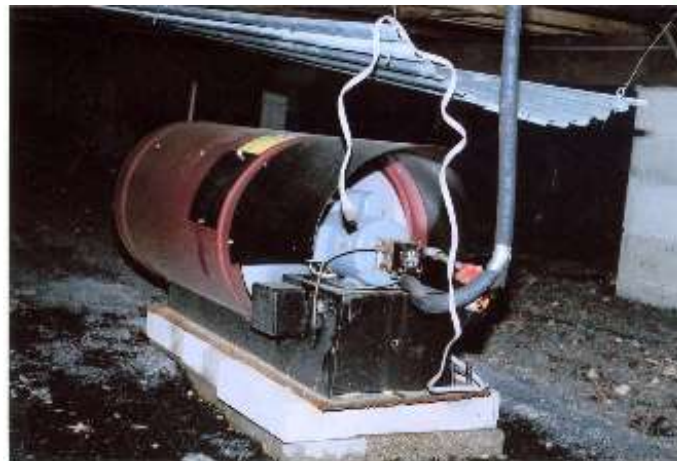
Photo 4

Luckily, no one was utilizing the racquetball court at the time of the incident. Severe damage was found underneath the racquetball court where oil heaters and fans were located to heat the court since it was located in a temperate climate location, photograph 4.

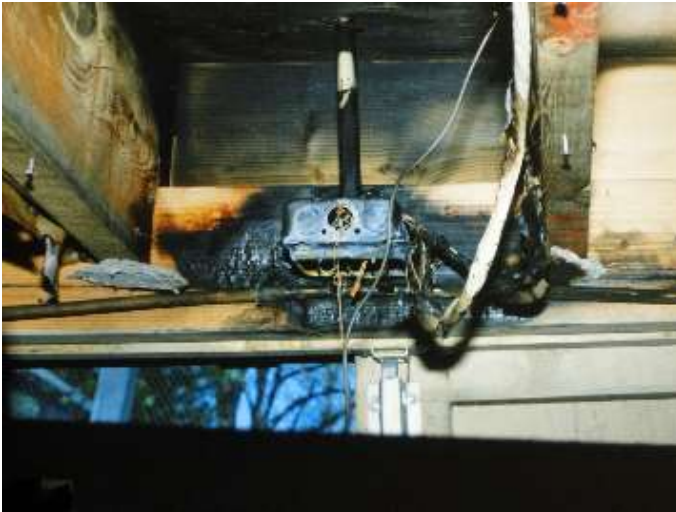
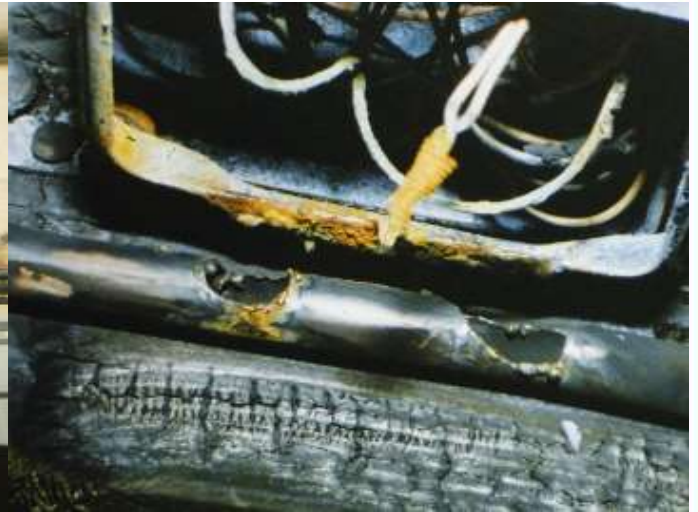
The ground conductors of various appliances that were plugged in at the time of the incident were burned away. Ground conductors of wiring within the club house were damaged, photograph 8, and evidence of electrical arcing was found on a fuel line, photograph 9. Fortunately, the fuel in the line did not ignite.

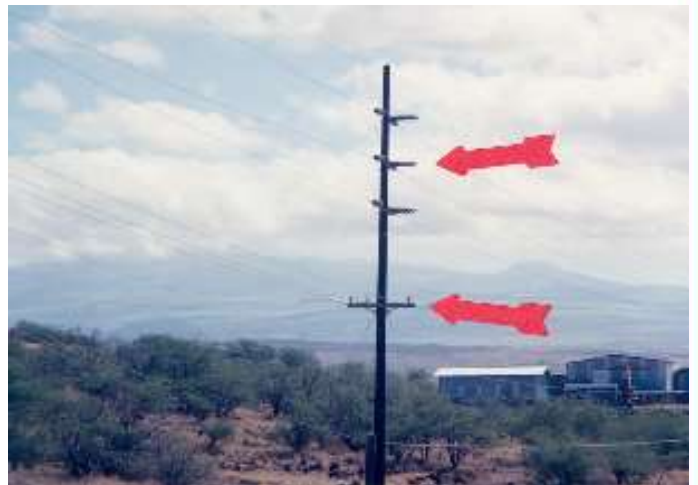
Photo 14

Two levels of power lines were on the utility pole with 69 kilovolt lines at the top, photograph 14.

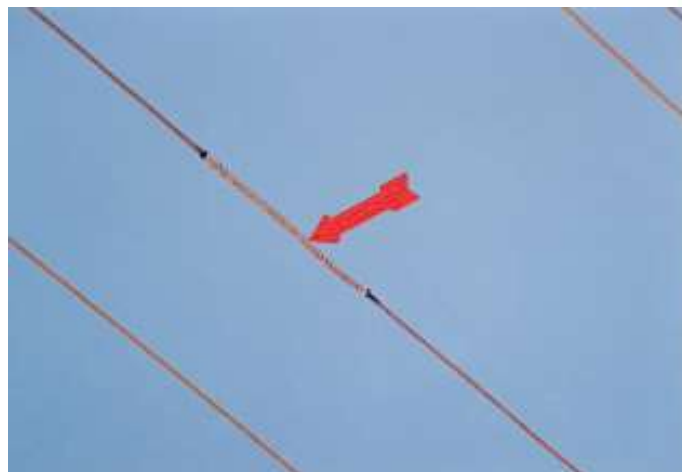
Photo 15

Inspection of the power lines found splices in the power lines, photograph 15.

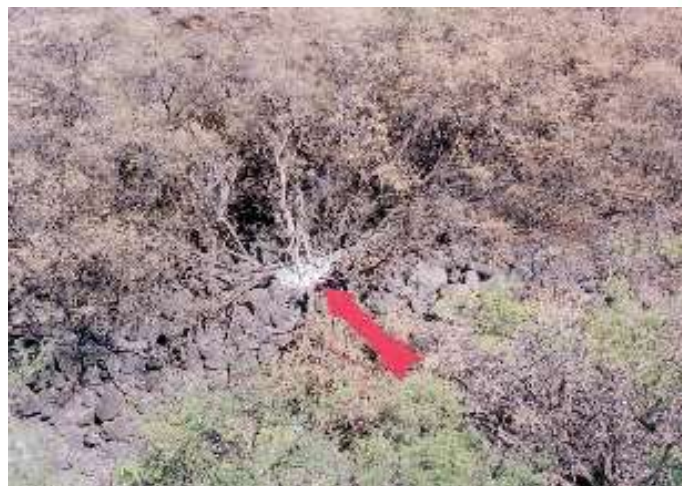
Photo 16

The power lines crossed over a gully where burning was still occurring underneath a twelve centimeter layer of ash at the time of the investigation, photograph 16

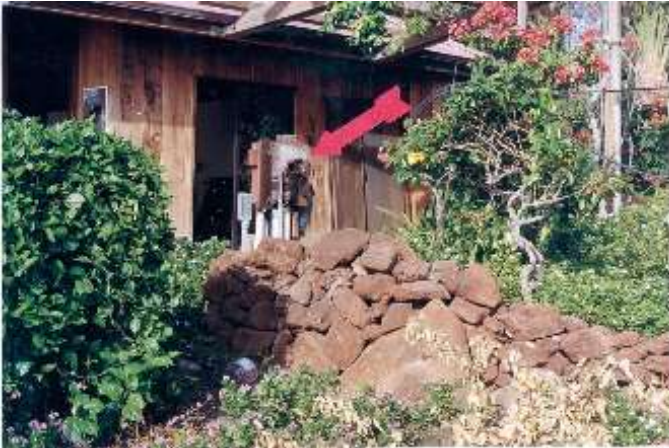
Photo 19

Electrical ground conductors were found severely heat damaged in buildings that were not ignited by the fire as the result of an electrical power surge, photographs 19 and 20.

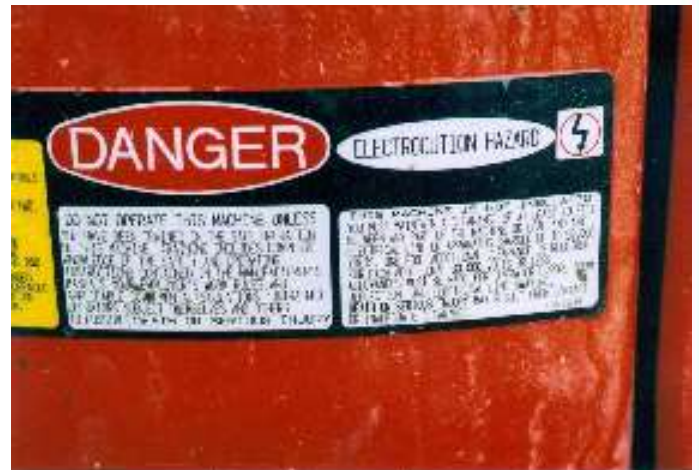
Photo 22

The manlift had warning labels on it, photograph 22 which read, "Danger electrocution hazard". "Do not operate this machine unless you have been trained in the safe operation of this machine." "Training includes complete knowledge of safety and operating instructions contained in the manufacturer's manuals". "This machine is not insulated". "You must maintain a clearance of at least 10 feet between any part of the machine or load and any electrical line or apparatus charged up to 50,000 volts."

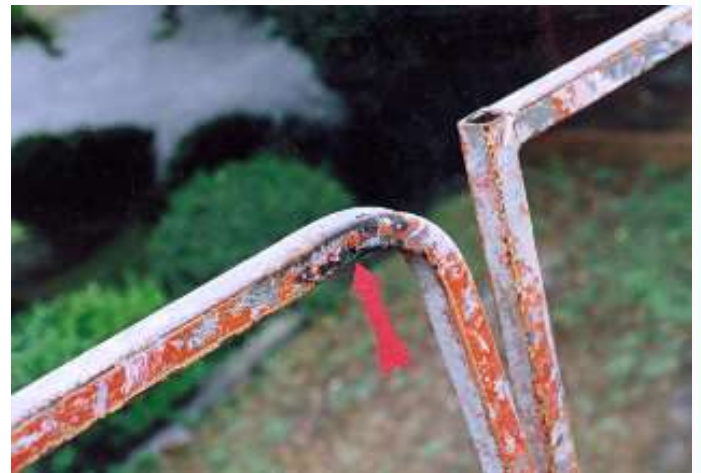
Photo 25

Inspection of the interior side of the entrance gate revealed evidence of burning and clothing material adhering to it, photograph 25.

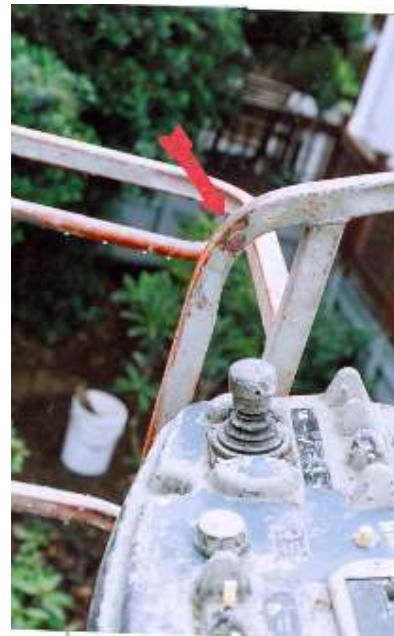
Photo 26

Evidence of burning was also found on the frame of the platform near the operator's controls, photograph 26.

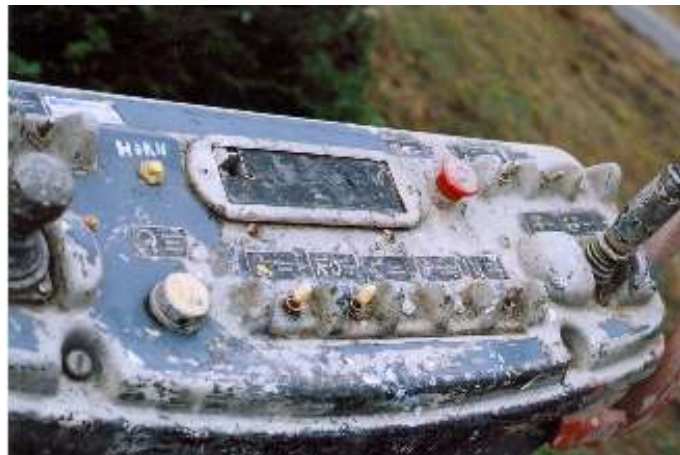
Photo 27

The operator's controls were covered with spackling materials, photograph 27.

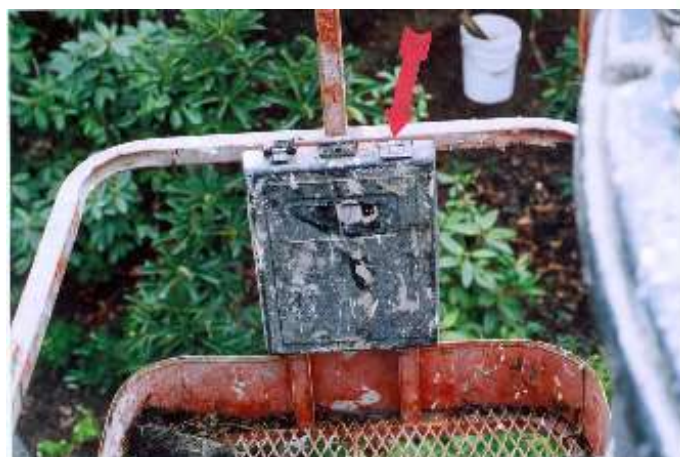
Photo 28

An unlabeled black box was found on the platform which was also covered with spackling materials, photograph 28.

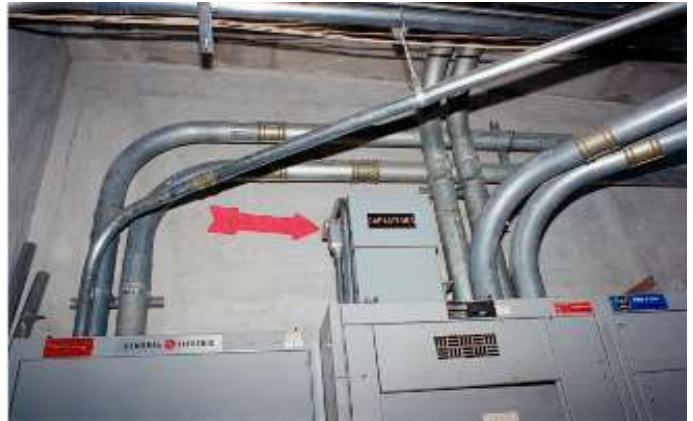
Photo 29

An electrical contractor had installed capacitors on a motor control center to improve the power factor of the electricity coming into the building, photograph 29.

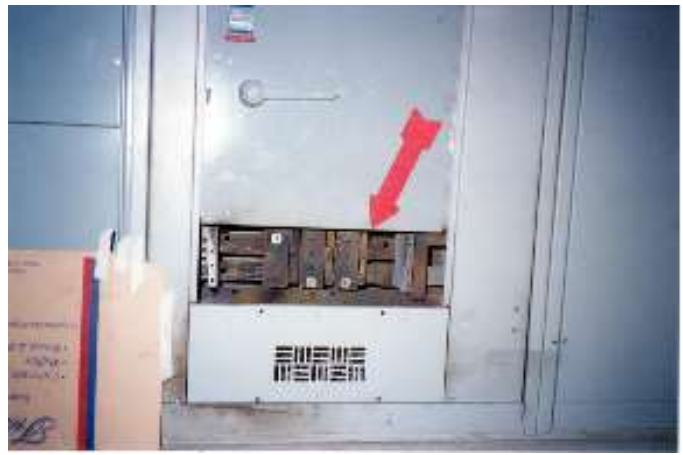
Photo 34

The cardboard covering the bottom opening of the motor control center was removed and evidence of burning and arcing was found within it, photograph 34.

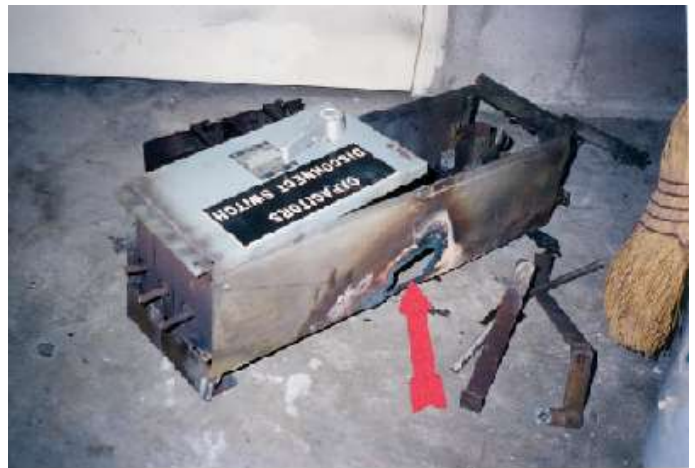
Photo 35

The disconnect switch that was previously located in the burned opening had been retained, photograph 35.

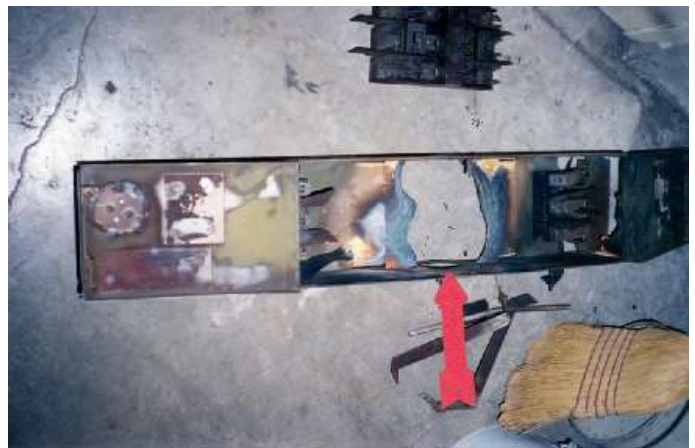
Photo 36

Electrical arcing burned a hole through the steel at the top of the unit and through its back, photograph 36.

contact between a charged 277 volt component and the grounded enclosure. This caused an arc blast within the unit that vaporized copper and steel components of the compartment. Since he was bending over in front of the compartment at the time, he was severely burned from the top of his head to his waist.

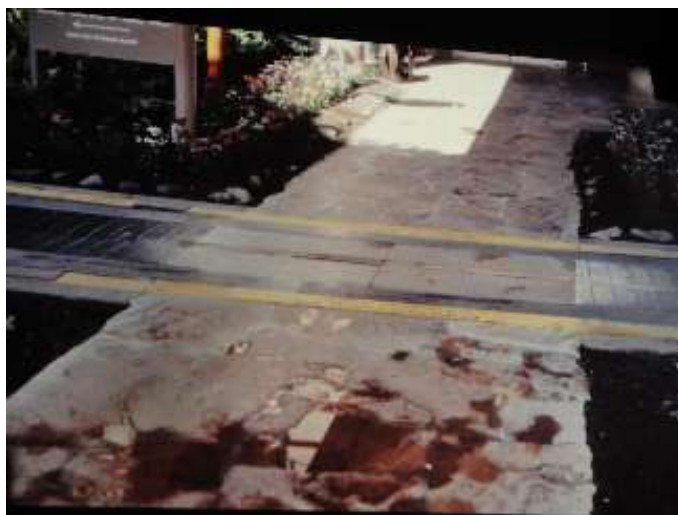
Photo 38

A maintenance manager at the hotel had found a loose cover over the electric train track which passed through a pedestrian walkway, photograph 38.

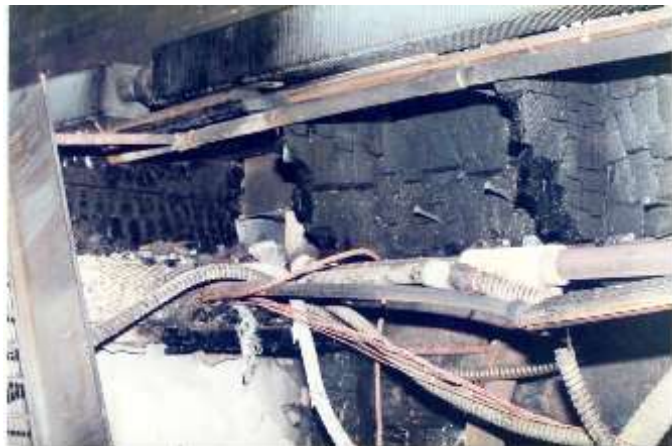
Photo 48

Electrical copper and aluminum wiring was found passing through the area of fire origin, photograph 48.

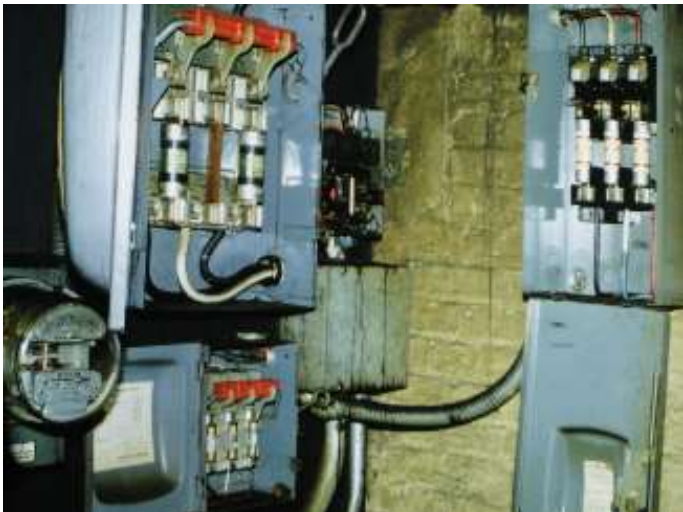
Photo 49

Fused disconnect switches located in the basement of the church supplied electrical power to the wiring which passed through the area of origin, photograph 49.

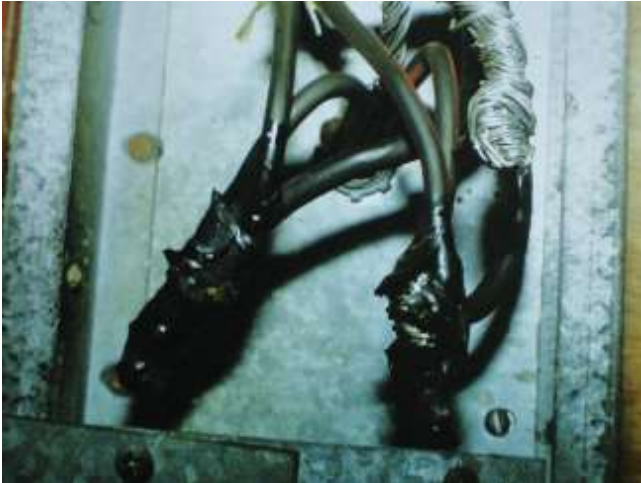
Photo 53

The aluminum wiring was traced to a second-floor gymnasium attached to the church that was utilized to play basketball. The aluminum wiring was spliced within a junction box in the gymnasium that fed power to an electrical receptacle. When the junction box was opened, a distinct odor of burning electrical insulation was detected and evidence of overheating was found on the spliced wiring, photograph 53.
