FIREPOINT

Issue 4

August 2017

AAFI Journal

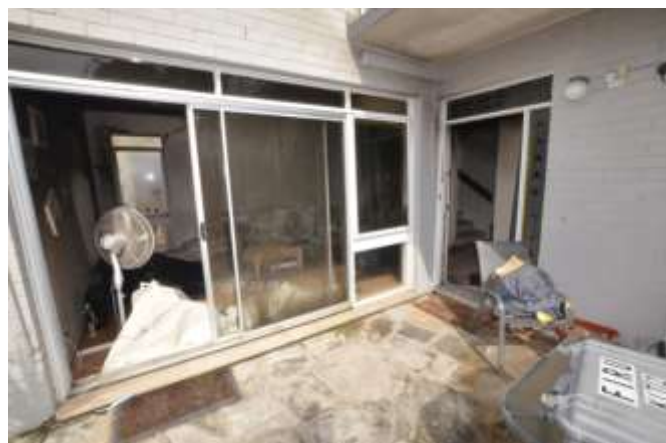
Figure 6 showing the balcony of the unit looking into the living room and front door.

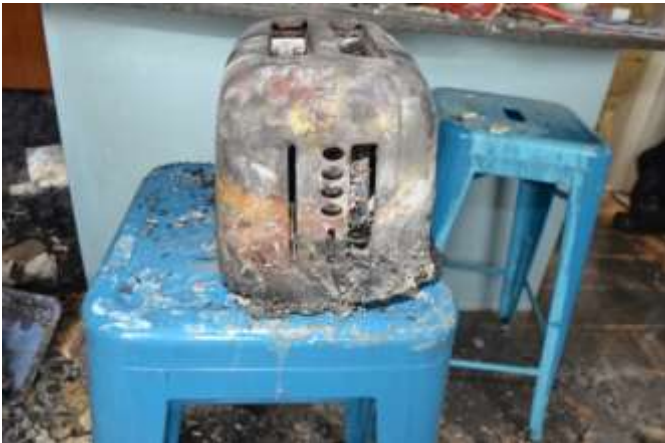
- The kettle showed fire damage from above, with the underneath plastics still intact. This device was ruled out as the source of ignition⁵ (refer Figure 11 and Figure 12).
- The toaster was located on the right side of the enclosed appliance cupboard. When removed the toaster had plastic fused to its right side. The left side showed a horizontal oxidation⁶ burn pattern (refer Figure 13). This indicated that the heat came from above and from the left side of this device. The base of this device had underneath plastics not melted (refer Figure 14). This device was ruled out as the source of ignition.
- The sandwich press was located on the left side of the enclosed appliance cupboard (refer Figure 15). Its right arm was melted with minimal damage underneath (refer Figure 16). This device was ruled out as the source of ignition.

Figure 13 showing the toaster. Note the oxidation on the left side.

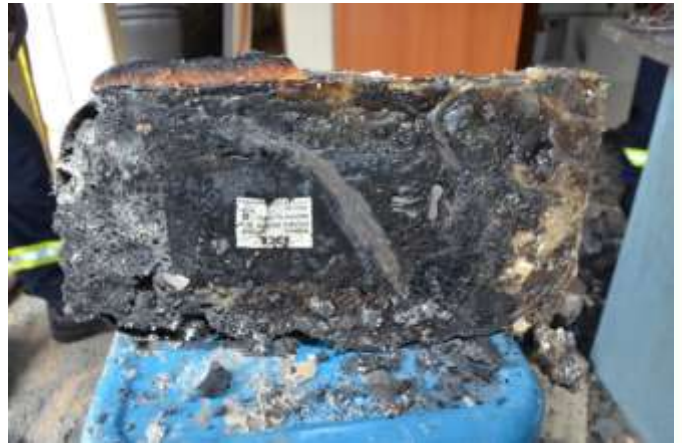
Figure 14 showing the underneath of the toaster. Note the plastic still intact here.

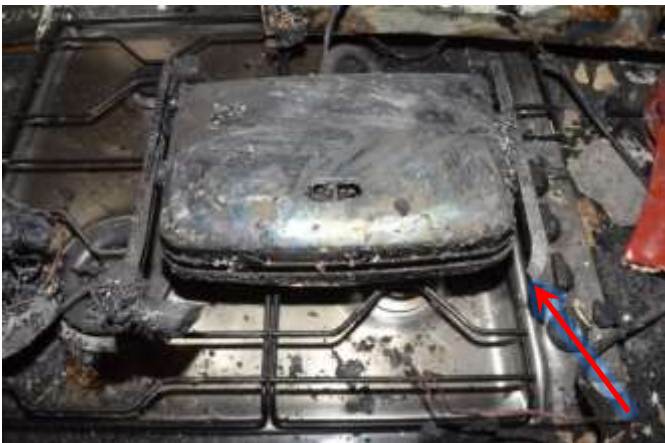
Figure 15 showing the sandwich press. Note the melting to the arm on its right side.

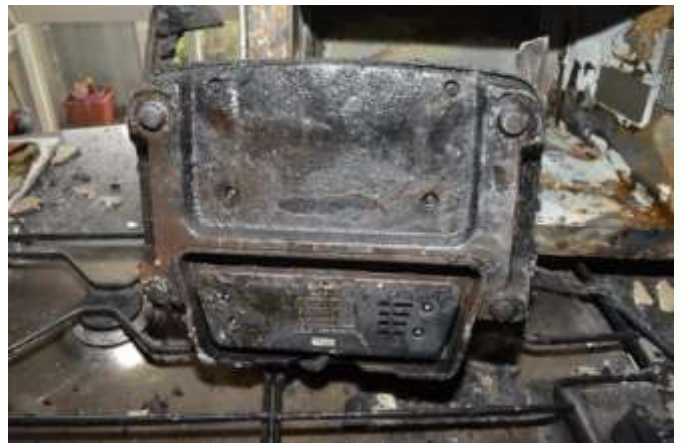
Figure 16 showing the underneath of the sandwich press. Note the plastic still intact here.

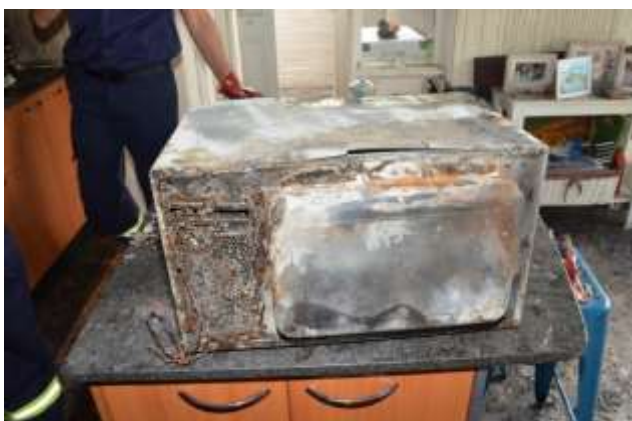
- The Ninja blender was located on the left side of the enclosed appliance cupboard (refer Figure 17). This device showed greater damage on its right side, with protection on its left side (refer Figure 18). There was no heat damage underneath. This device was ruled out as the source of ignition.
- The microwave showed severe fire damage with oxidation on most sides (refer Figure 19 and Figure 20). No plastic remained on the device. This appliance was located on shelf above the enclosed appliance cupboard and the 4 gang GPO⁷. This appliance is a possible ignition source.

Figure 19 showing the rear of the microwave.

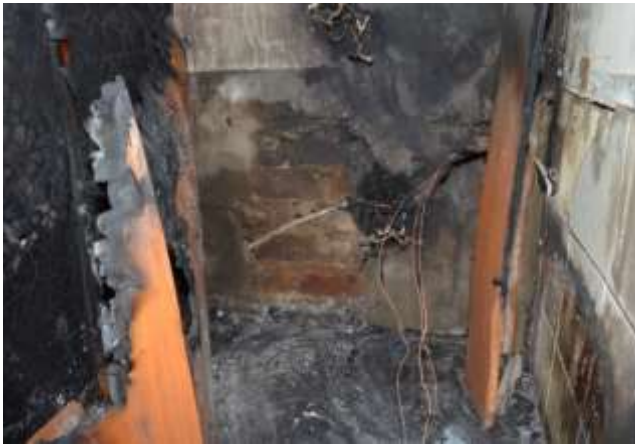
- A 'V' pattern⁸ of burning to the timber cupboard on eastern wall with its base pointing back to a 4 gang GPO. The timber backing sheet of the cupboard was pulled out and this showed a hole in timber sheet around the 4 gang GPO (refer Figure 21 and Figure 22).
- 4 gang GPO was examined. 3 buss bars remained. 2 which were of brass colour were the active and neutral while the remaining dark black one was the earth. The 2 brass coloured buss bars both had a red colouring to their right side. This appeared to be a hot joint. This was the POO⁹.

Figure 21 showing the wall behind the timber backing.

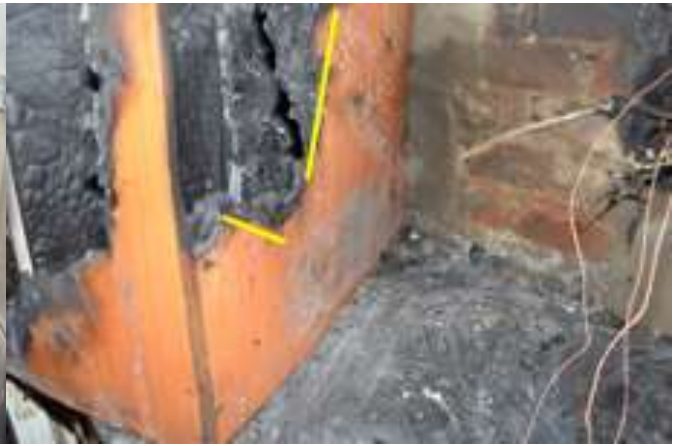
Figure 22 showing the back of the timber cupboard.

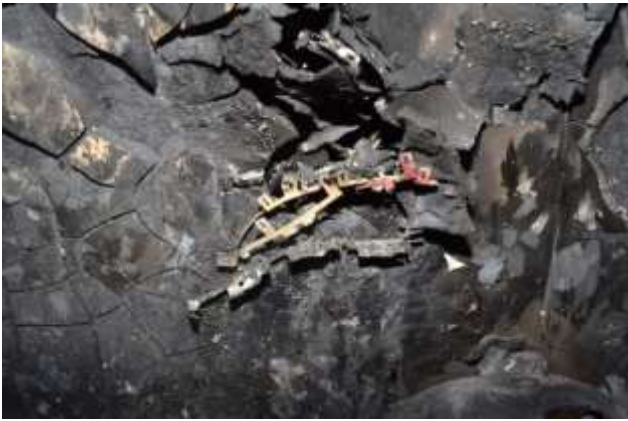
Figure 23 showing the remains of the busbars.

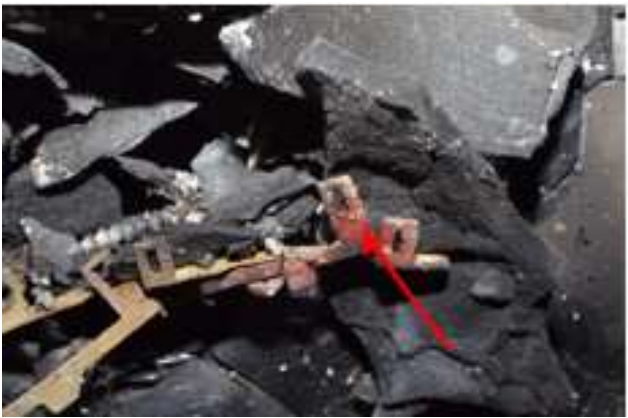
Figure 24 showing a close up of the right side. Note the discolouration of the busbars.

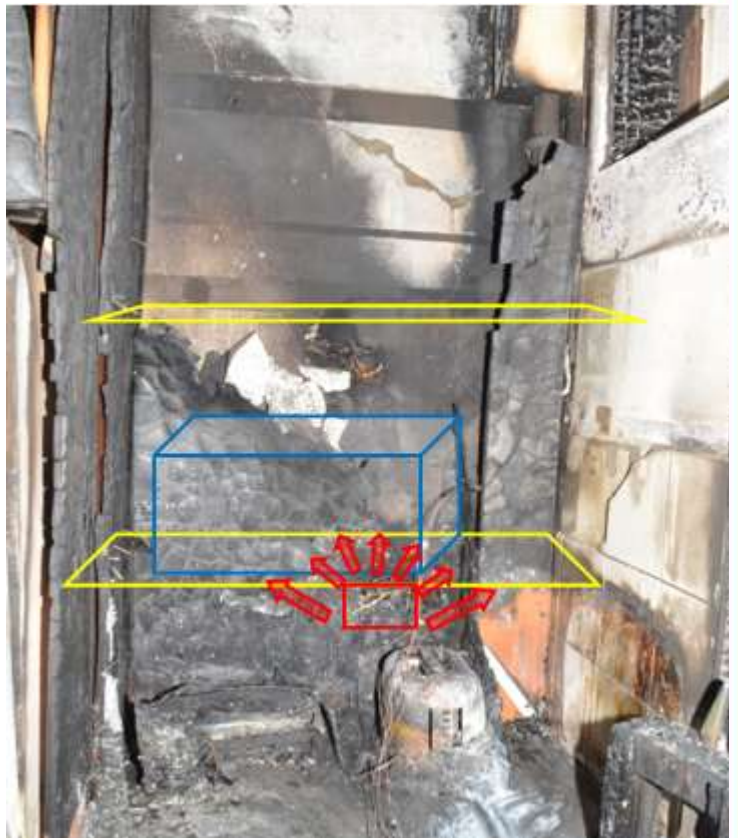
Figure 25 showing the excavated area with appliances in their original positions. The 4 gang GPO is above the toaster. The locations of the shelves are in yellow. The approximate location of the microwave is shown in blue.

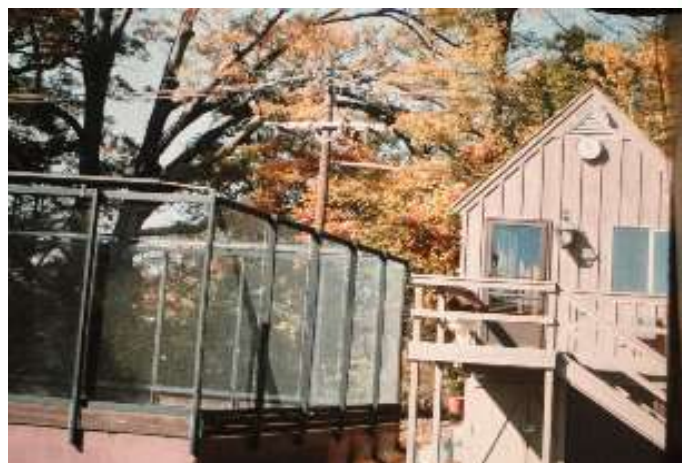
Photo 1

The first example involves an electrical accident or more appropriately an electrical incident which occurred at a sporting club. The incident originated at an outdoor racquetball court, photograph 1.

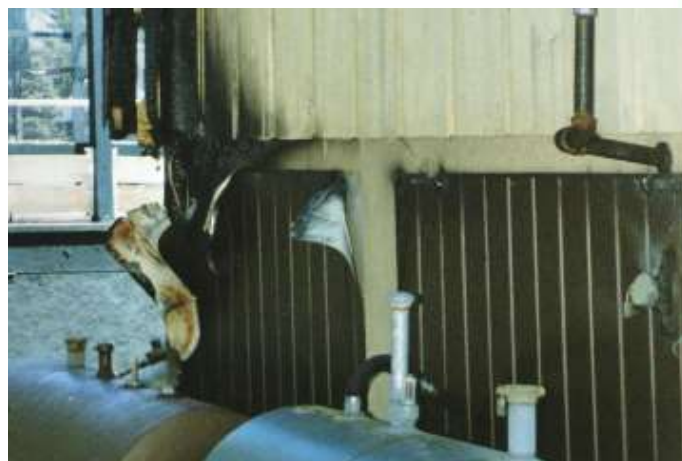
Photo 5

None of the fuel ignited even though there was evidence of electrical arcing surrounding the fuel storage tank, photograph 5.

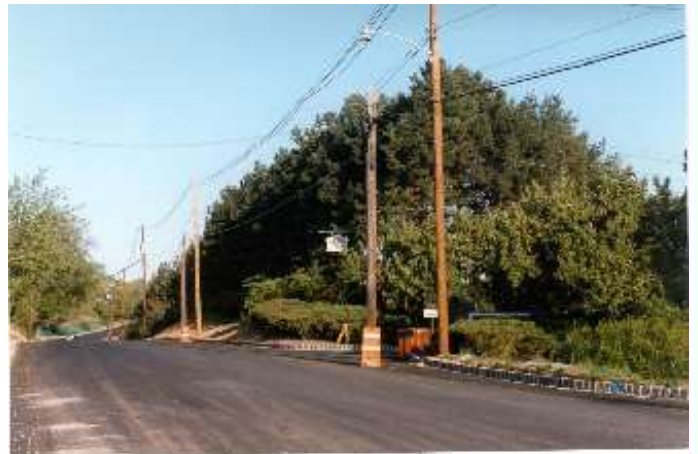
Photo 10

Inspection of the area surrounding the sporting club found that the local utility was installing power line poles and power lines at the time of the incident, photograph 10. There were no environmental factors that could have caused the line to fall since the weather was clear at the time of the incident.

Subsequently, the power line most probably fell down as a result of the work activity in the area by the utility company.

The damage was the result of installing an electric power line above the metal racquetball court in violation of electrical code requirements. The National Electrical Safety Code [12] requires a vertical clearance of 3 meters above the metal racquetball court and a horizontal clearance of 2.4 meters.

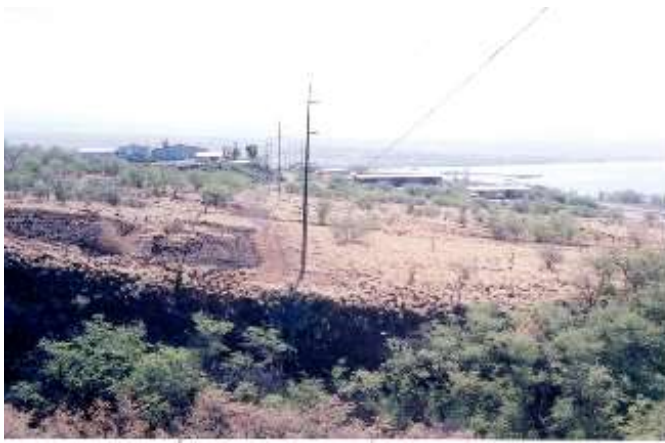
Photo 11

The next example involves a wildland fire. A wildland fire is a fire which originates in an uninhabited area of land. It might subsequently spread and damage/destroy inhabited buildings and areas of land. Inspection of the burned land areas indicated that the fire originated near a utility electric pole, photographs 11 and 12.

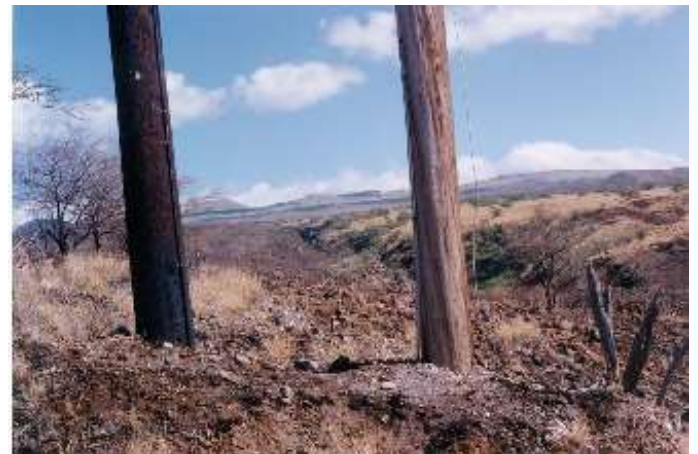
Photo 13

The utility pole was made of wood, photograph 13.

The power line came down because the wind in the area quite frequently exceeded the capacity of the components on the wooden utility pole in the area of fire origin after sunset. The wooden poles were replaced with metal poles that have a higher wind capacity and they look like wooden poles from a distance.

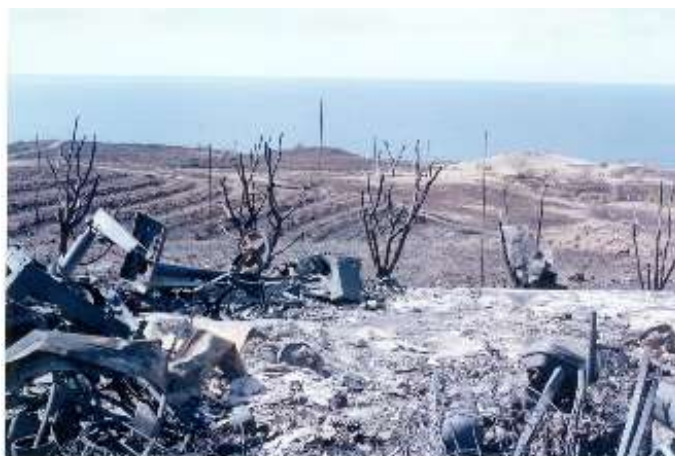
Photo 17

The power lines were traced to the utility substation which controlled them. The wildland fire had destroyed vegetation and buildings in its path as it spread, photographs 17 and 18.

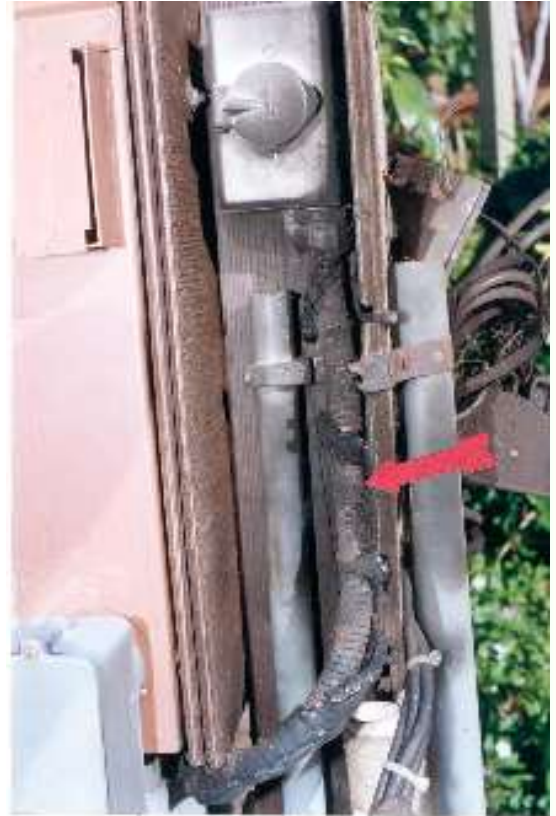
Photo 20

Electrical ground conductors were found severely heat damaged in buildings that were not ignited by the fire as the result of an electrical power surge, photographs 19 and 20.

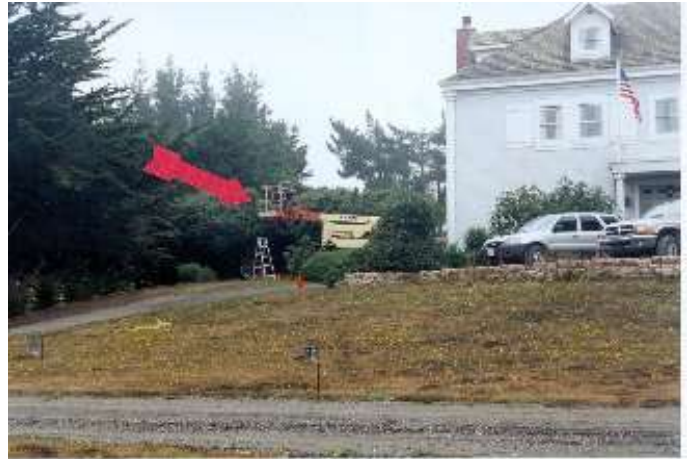
Photo 21

The maintenance worker had been assigned the task of cleaning the roof gutters on a large three-story building utilizing a motorized man lift, photograph 21.

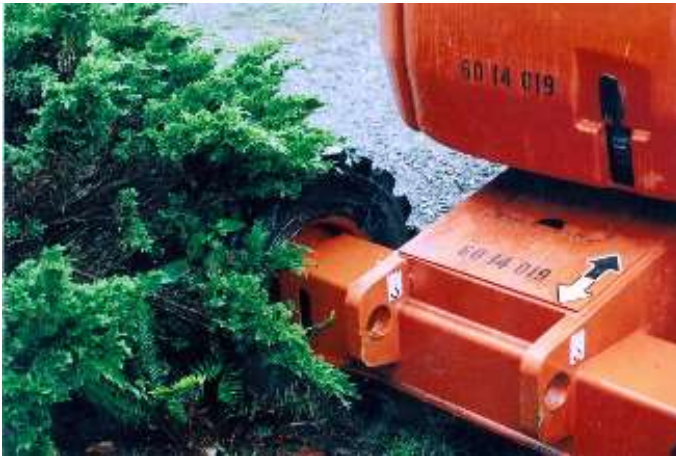
Photo 23

The tires and base of the manlift were in contact with wet vegetation near the perimeter of the building, which provided a high resistance current path from the lift's base to ground, photograph 23.

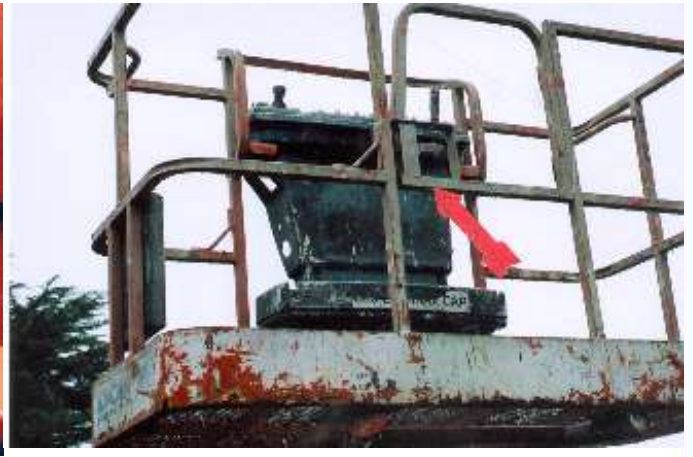
Photo 24

This manlift did not have outriggers on it. Outriggers are devices which extend from the base of the lift in order to provide stability, particularly when the lift platform is raised. Outriggers are normally made of metal, which would have provided a low resistance current path from the lift to ground. The operator's platform could be entered through a metal gate on the platform, photograph 24.

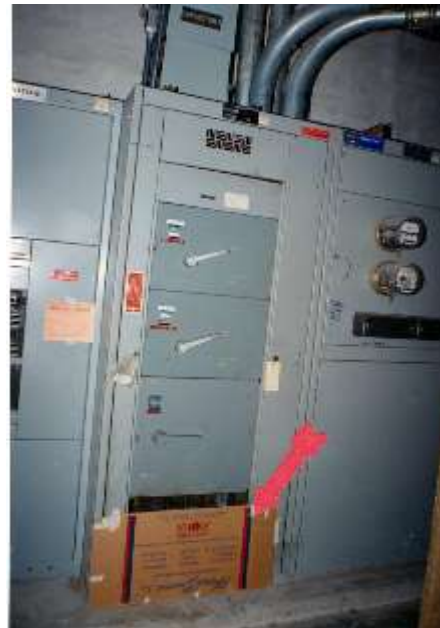
Photo 30

Electric utilities quite frequently charge their customers additional fees for bad electrical power factors. Power factor is the ratio of total watts to the total root-mean-square of volt-amperes [19]. A disconnect switch for the capacitors was installed in the bottom of the motor control center, photograph 30.

The electrical contractor did not install the correct door to operate the capacitor disconnect switch in the bottom unit. Subsequently, the contractor asked a maintenance worker of the building to replace the door with the correct unit. The motor control center had warning labels on it. One warning label stated "DANGER: hazard of electrical shock or burn. TURN OFF POWER supplying this equipment before working inside.", Photograph 31.

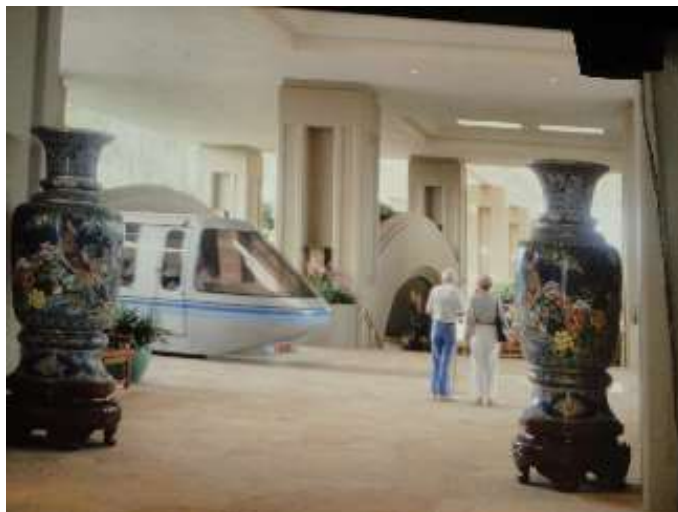
Photo 37

The hotel had four ways of traveling from its registration desk to its guest rooms; walking, golf cart, boat or electric train, photograph 37.

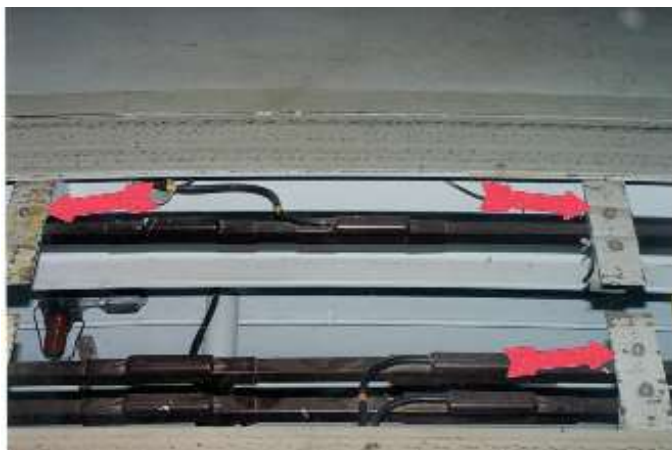
Photo 39

The walkway was wet since the canal for the boat system was located in close proximity 2 meters away. The maintenance manager was concerned that a guest might slip and fall and hurt themselves. Therefore, he attempted to tighten bolts which held the covers in place, photograph 39. While reaching underneath the train track cover, he was electrocuted.

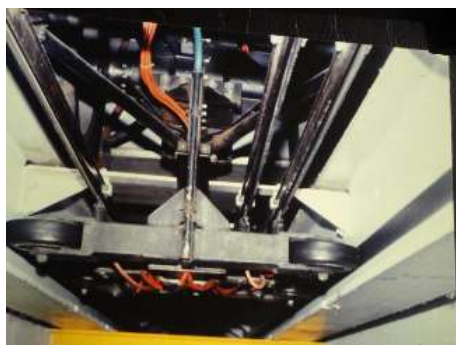
Photo 40

Examination of the underside of the train revealed that it received electrical power from electrical buss bars energized with 480 volts of alternating current beneath it, photograph 40. Electrical contact shoes, photograph 41, would slide in a groove of the buss bars as the train moved along its track to obtain power for its traction motors, photograph 42.

No evidence was found that the manager made contact with the buss bars. However, an electrical joint compound which conducts electricity was found between the buss bars and bolts which held the train track cover in place. Subsequently, the man was electrocuted when he touched the electrical joint compound while kneeling on the wet concrete walkway which grounded him. Electrical current entered his body through his hand, passed through his heart and exited out his knees, killing him.

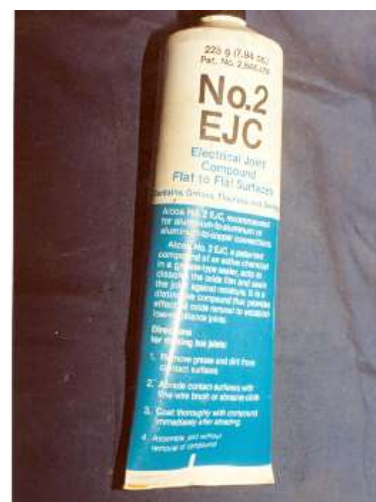
Photo 43

An electrical joint compound was utilized to reduce the electrical resistance between the buss bars and electrical shoes, photograph 43.

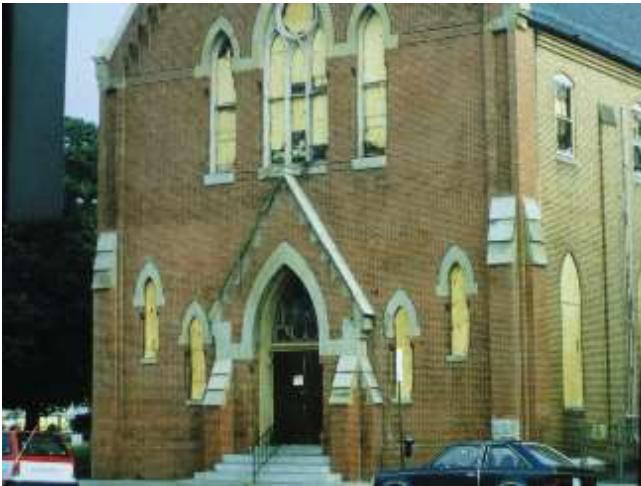
Photo 44

The sixth and final case study is that of a church fire, photograph 44. This church was utilized by two different denominations, with differing beliefs and an arsonist was known to be active in the area.

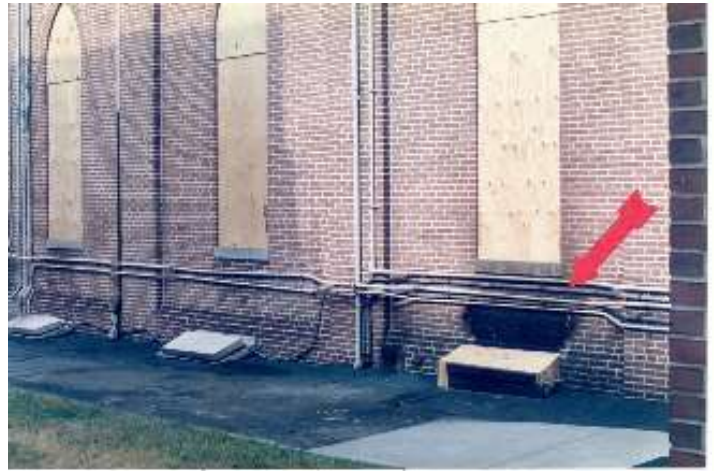
Photo 45

A clockwise inspection of the church exterior found smoke residue around an opening along its base near the Northeast corner, photograph 45.

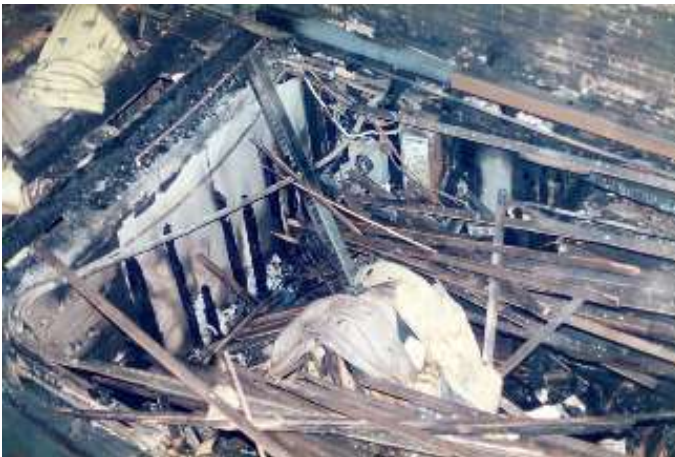
Photo 46

Examination of the burn patterns within the church indicated that the fire originated in the Northeast corner below the first pew, photographs 46 and 47.

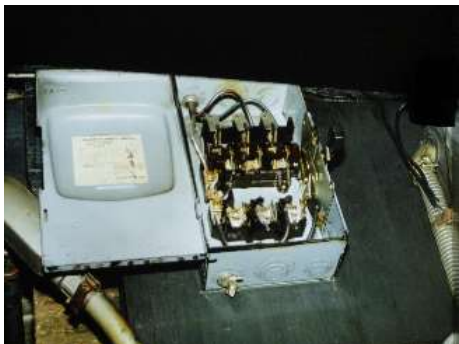
Photo 50

One fused disconnect switch was missing its fuses and the aluminum wiring previously attached to it had been cut off, photograph 50. Heat damage was found on the cut-off wires, photograph 51. The manufacturer's label on the inside of the fused disconnect switch was clearly heat damaged, photograph 52.

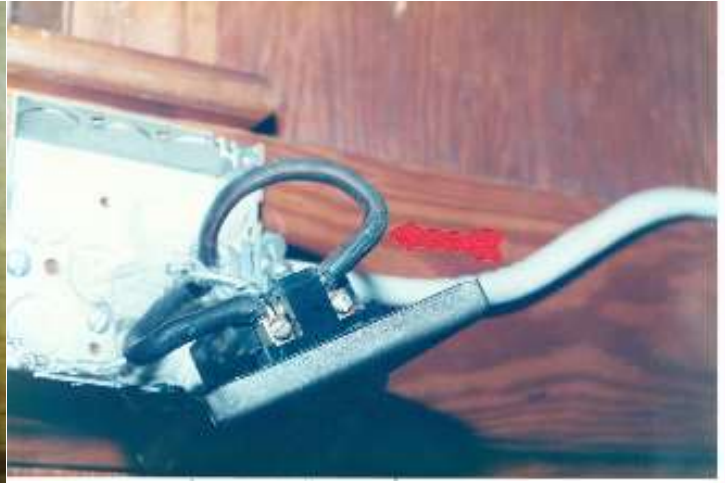
Photo 54

The insulation of the aluminum wiring attached to the receptacle showed evidence of overheating, photograph 54. The receptacle had a room air conditioner plugged into it that did not have the capacity to cool the gymnasium. Therefore, it would draw its maximum rated current when turned on. Testing of the air conditioner found that its compressor motor had shorted out and it would draw more current than rated when turned on. On the day of the fire, there was basketball practice in the gymnasium and the temperature outside the building exceeded 38°C.

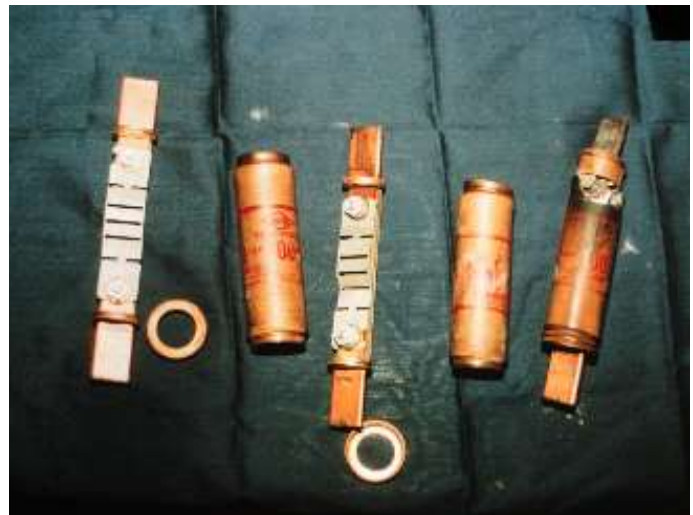
Photo 55

Electricians making repairs in the church were contacted and the fuses previously located in the fused disconnect switch were obtained, photograph 55.

The fuses were rated at 100 amperes and showed evidence of overheating, but they had not opened. The aluminum electrical wiring that they protected was rated at 50 amperes. The 100 ampere fuses would not properly protect the 50 ampere wiring and the resistance of the excessively long circuit limited the fault current. Consequentially, the fire was caused by overheated aluminum wiring that passed through the area of fire origin where heat was entrapped by wooden framing which eventually ignited.

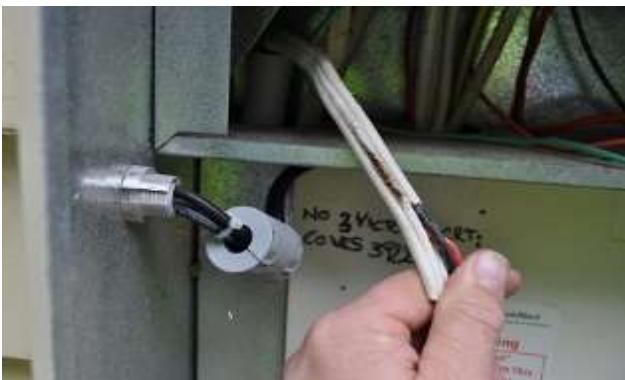
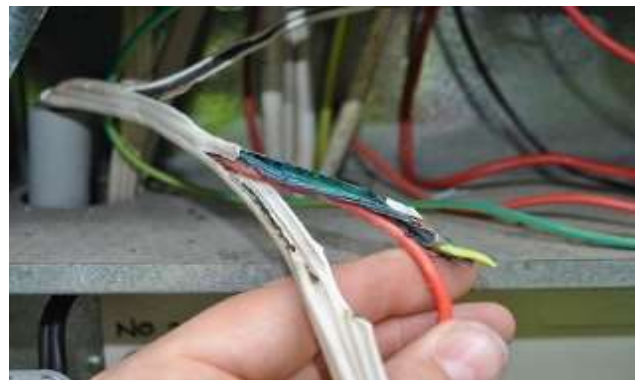
Evidence of a broken distribution cable neutral at a fire scene at a domestic property
